# Steynton Pumping Station

## planning for success

by  
Mark Paduch BSc Hons

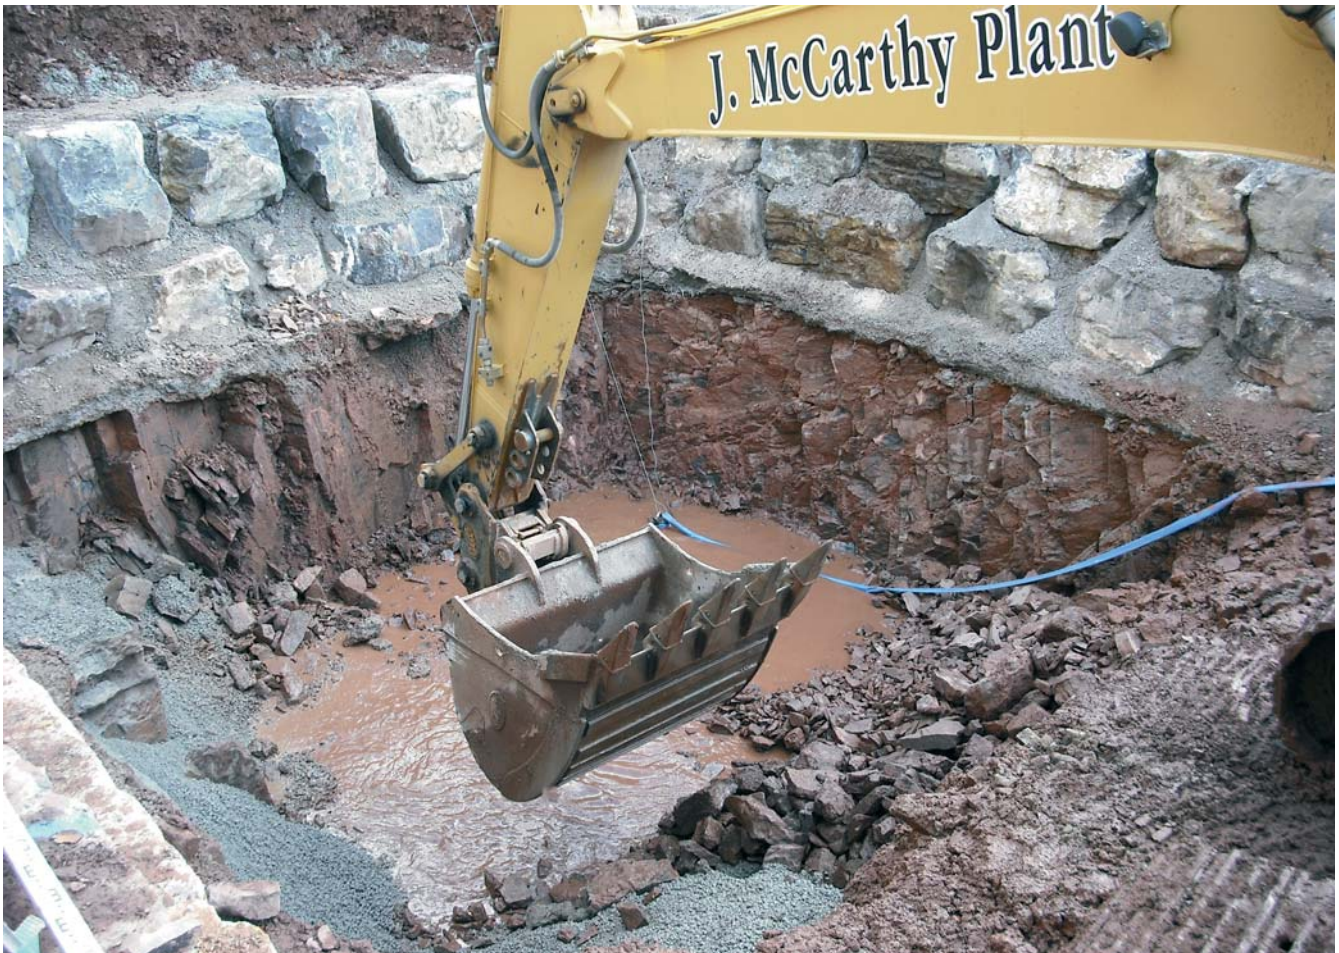
Excavation to Formation

Limited ground investigation prior to the project highlighted the presence of rock at 2.5 to 4m depth dependent on location within the site. In order to further quantify the rock and select an appropriate excavation method to proceed with, an independent Geologist's services were engaged. Dr J.S. Noake joined the project team for two days and through bespoke trial holes, quantifying of the strata and careful consideration, an appropriate method to proceed with was identified.

The 2.5 to 4m layer (Layer 1) was identified as a medium dense to dense, cohesionless, slightly silty sand with angular gravel and cobbles of marly sandstone. The underlying bedrock was identified as a thick bedded, wide space jointed, extremely strong marly sandstone of lower Devonian age (Layer 2).

The two differing layers required a dual approach in respect of stability of the excavation during pipe installation. 'Layer 1' was excavated down to underlying bedrock level. Due to constrictions in site width a 45° angle of batter was not achievable and mechanical shoring was not an option due to excavation width. The proposed solution was to install a Blockstone wall bedded in concrete at the

underlying bedrock level. This coupled with the use of rock netting provided stability to the exposed slope and prevented loose debris falling into the excavation below.

'Layer 2' required no additional shoring. Standard excavation methods were adopted utilising a 34 tonne excavator and rock hammer.

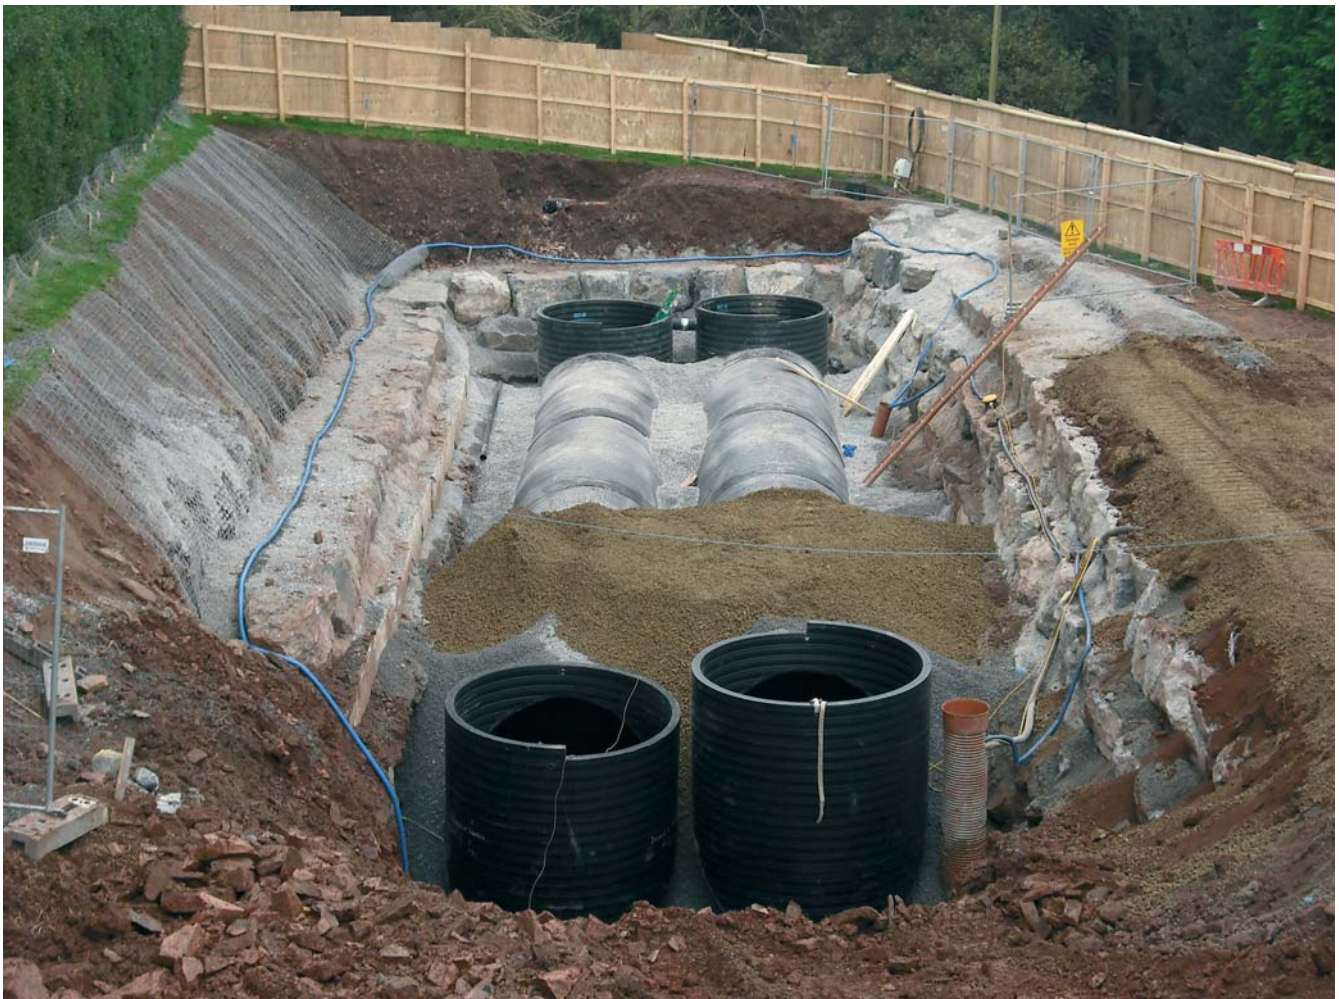
Processed Top Backfill Layer

Morrison Construction applied for an exemption under 'Paragraph 13' from the Environment Agency in order to carry out the proposed activities at Merlins Bridge, which was granted by the EA. The material was hauled to Merlins Bridge where it was processed in a number of ways to produce a product fit for re-use. Through the use of grated sieve buckets, selective screening and crushing on site a product was produced in accordance with the 'Earthworks series 600' classification 6A.

In accordance with Asset International's installation process for their Weholite pipes and with approval from Asset's Senior Technical Engineer, Vasilios Samaras, the material was deemed suitable for backfilling up to the previous existing ground level. This resulted in the re-use of 750m<sup>3</sup> of the 2000m<sup>3</sup> initially excavated.

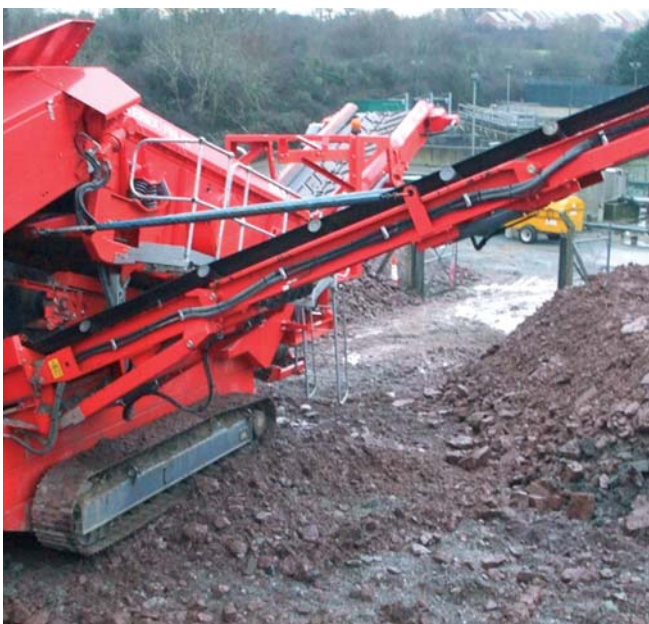
*Screening at Merlins Bridge*
